DATE 03/05/2008

Subject: 18-8077 Fuel Connectors

Models Affected: Mercury / Yamaha Outboards

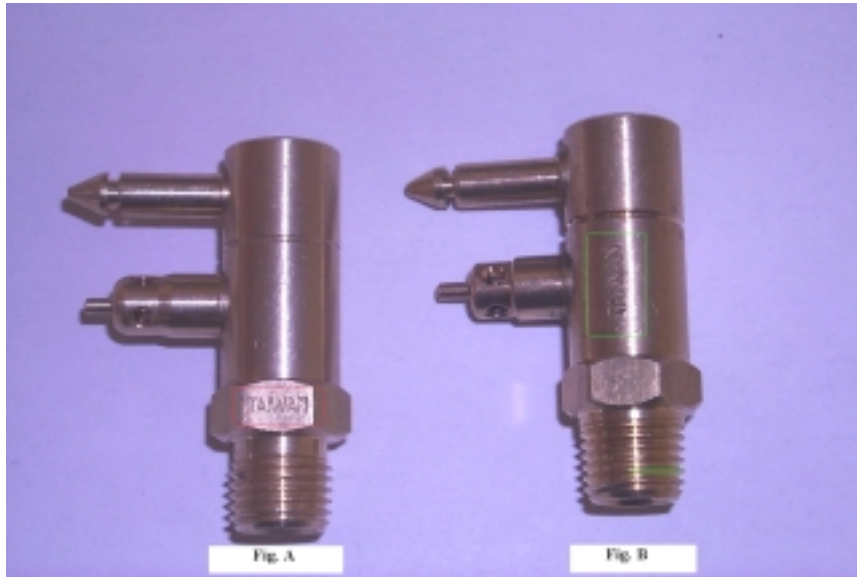
Sierra has identified an issue with the 18-8077 male tank fuel connectors. The flag on the male tank end connector is slightly shorter and will not allow the female hose connector to “lock” into the groove on the flag pin. The connectors that are affected are of a limited amount and are easily identified by the location of the country of origin location on the part.

If you have a male tank end connector part number 18-8077 and the country of origin “Taiwan” is stamped on the hex portion of the fitting (see Figure A), these fittings need to be returned for credit or replacement.

If you have a male tank end connector part number 18-8077 and the country of origin “Taiwan” is stamped on the body of the fitting (see Figure B). This fitting is NOT affected and will work in all intended applications.

Distributors: Please inspect fitting for country of origin location and contact Sierra’s Technical Service Dept. at 217-324-9428 to obtain a Return Goods Authorization #.

Dealers: Please inspect fitting for country of origin location and contact distributor for return instructions.

In-Service Parts: No action. Unless returned by customer with complaint of fuel line not locking into position on the tank fitting.
